## Test report # PF21065

**Test Number 21065**

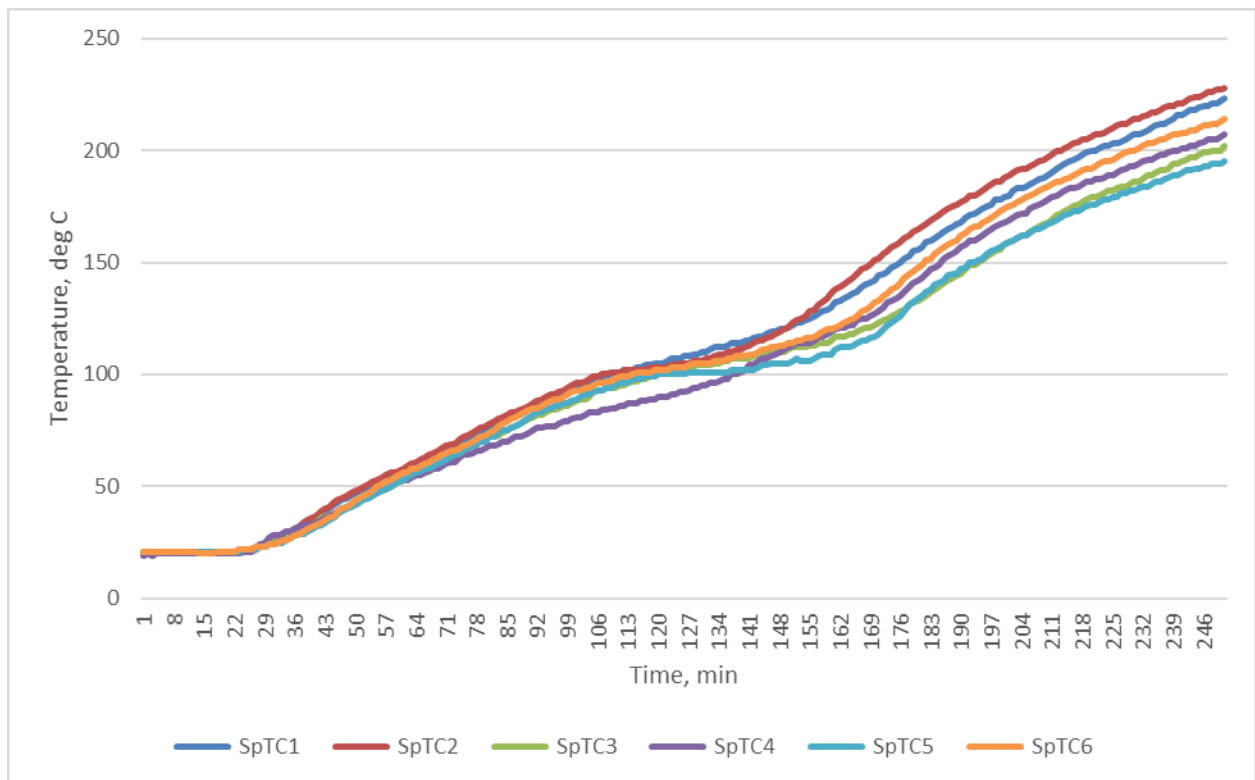
Roving thermocouple was applied to seal at 50 minutes, temperature exceeded 200°C - Insulation failure.

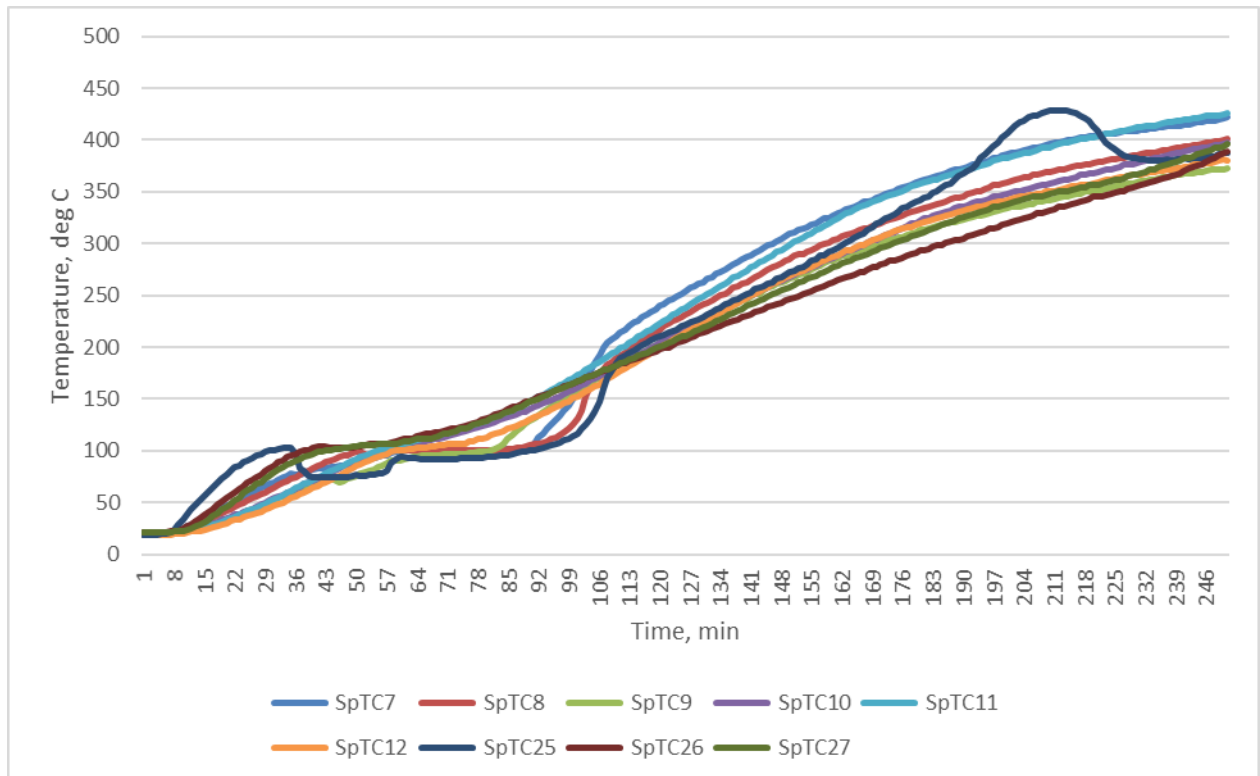
### Specimen B Thermocouples Readings

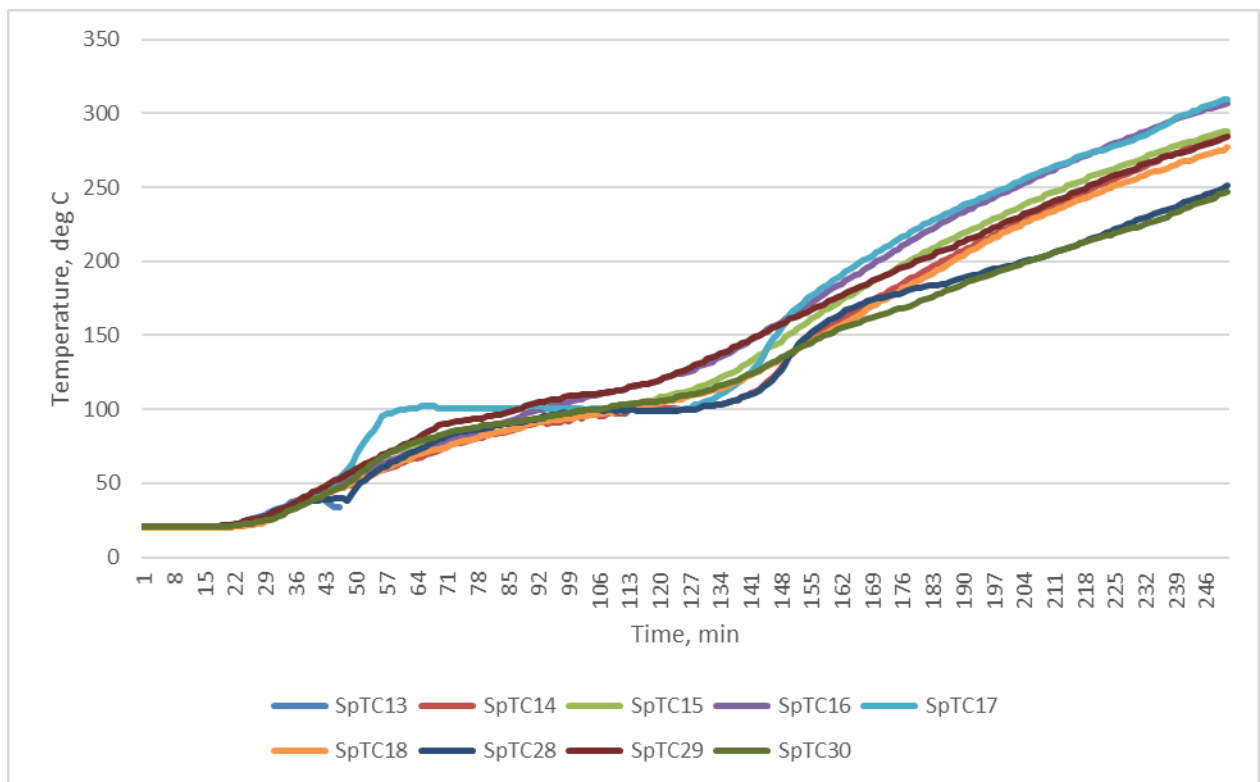
### Specimen C Thermocouples Readings

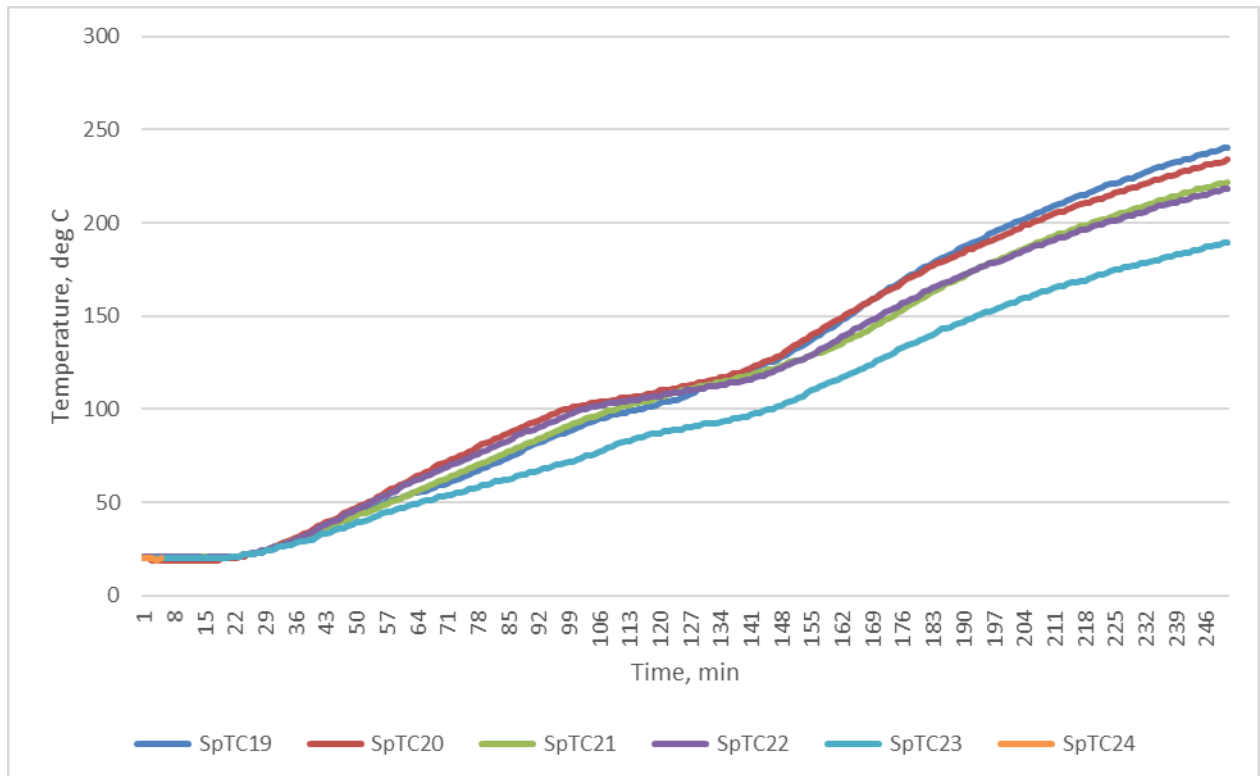
Roving thermocouple was applied to seal at 28 minutes, temperature exceeded 200°C - Insulation failure.
