Middle Head Fortifications Sydney Harbour National Park, NSW

CUSTOMER NSW National Parks and Wildlife Service
 SPECIFIER ACOR Consultants
 CONTRACTOR Dapcor
 SECTOR Heritage buildings
 DATE 2021

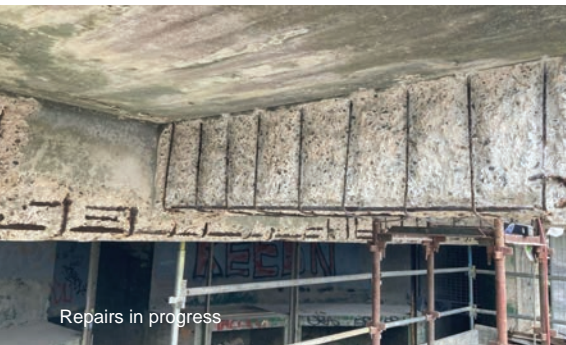
Repairs in progress

For deep repairs in excess of 50 mm, Renderoc LA55 Plus was applied. Renderoc HB40 Plus was used for smaller patch repairs. Both mortars will provide excellent protection against carbon dioxide and chloride attacks.

Before the Renderoc products, Nitoprime Zincrich was used to protect any exposed steel from corrosion. Nitobond EP was applied to help the exposed concrete bond with the new mortar.

As a final step, Concure X90 was applied to the fresh concrete. A water based hydrocarbon curing compound, it protects the mortar from evaporation. It was particularly vital as water curing was not possible at this site, where repair materials were walked in by the Dapcor team.

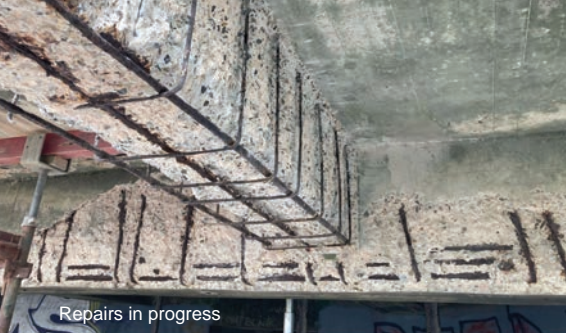
Repairs in progress
